Energy Savings Action Plan

OPD 004

- Penrith Civic Centre
- Ripples Hydrotherapy Pool
- Joan Sutherland Performing Arts Centre
- Lewers Gallery
- Carita Child Care Centre

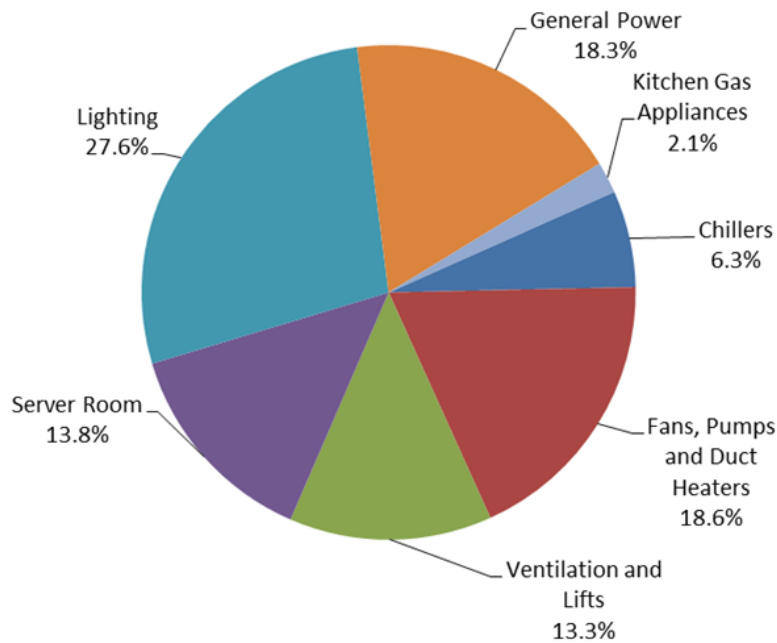
Figure 1: Breakdown of energy consumption, 2010-11

Combined, the HVAC (chillers, fans, pumps and ventilation) consumes the largest portion of the site’s energy (38.2%), which is a relatively low split as typically 50% of a building’s energy use is attributable to HVAC. There is a large server room onsite and the air conditioning component for this brings the total HVAC closer to the 50% mark. However, all things considered the HVAC is still running efficiently (with the exception of the server room). Lighting is the next-largest user at 27.6% and represents the most likely area where energy savings can be achieved.

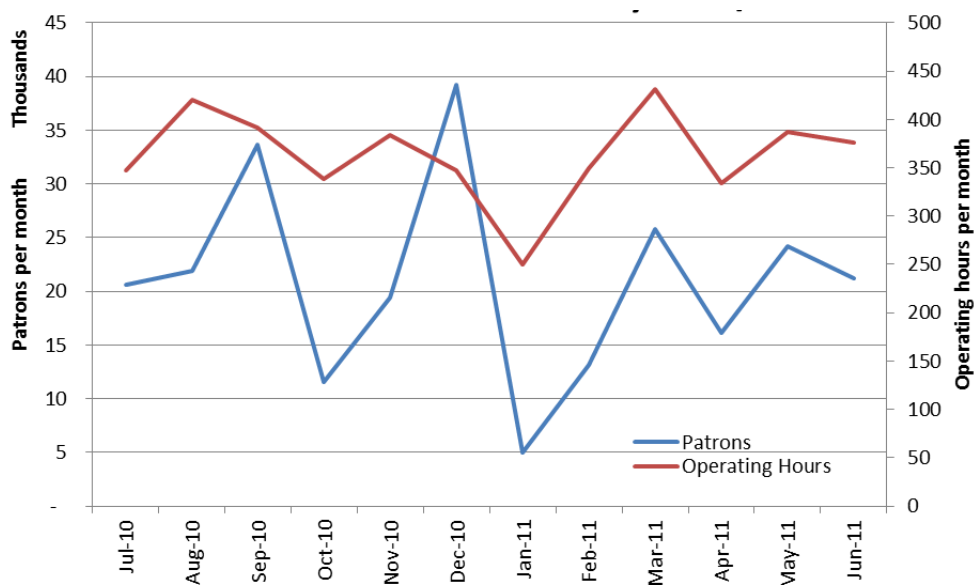
Figure 10: Monthly business activity data for the JSPAC, 2010-11

Figure 10 shows the large variability in patronage by month. This variability is governed by performance schedules in the concert hall and Q Theatre. Operating hours also show considerable variability across months, although less so than patronage figures. Both data sets show an annual low during January and February, and a peak at the end of the calendar year and in school terms.

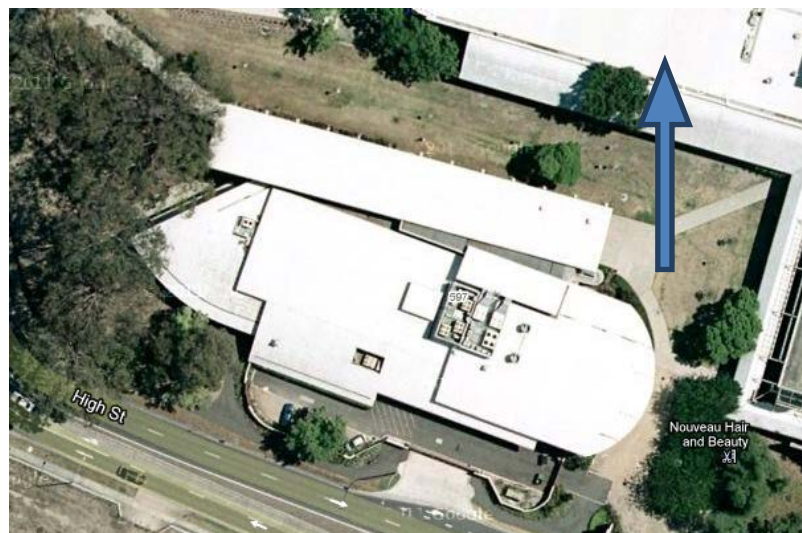
Figure 15: Aerial view of JSPAC showing large northern aspect

other profiles. The profile shows an early drop off from the peak consumption than expected, which may be due to the trees and roof to the western end of the JSPAC providing afternoon shading. By contrast, the large northern aspect has relatively little protection from the sun during the middle of the day as shown in Figure 15. This northern aspect glazing was also noted by site staff during the audit as contributing to overheating issues through solar gain (Figure 16).

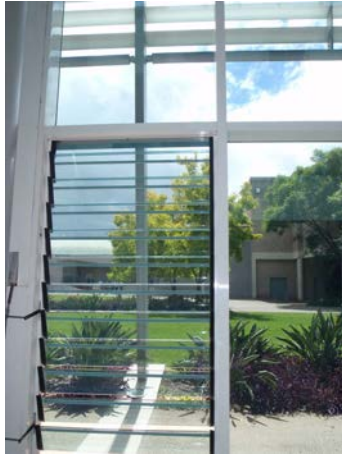
Figure 16: Solar gain through northern aspect glazing (taken at 12:44pm on 7<sup>th</sup> March)

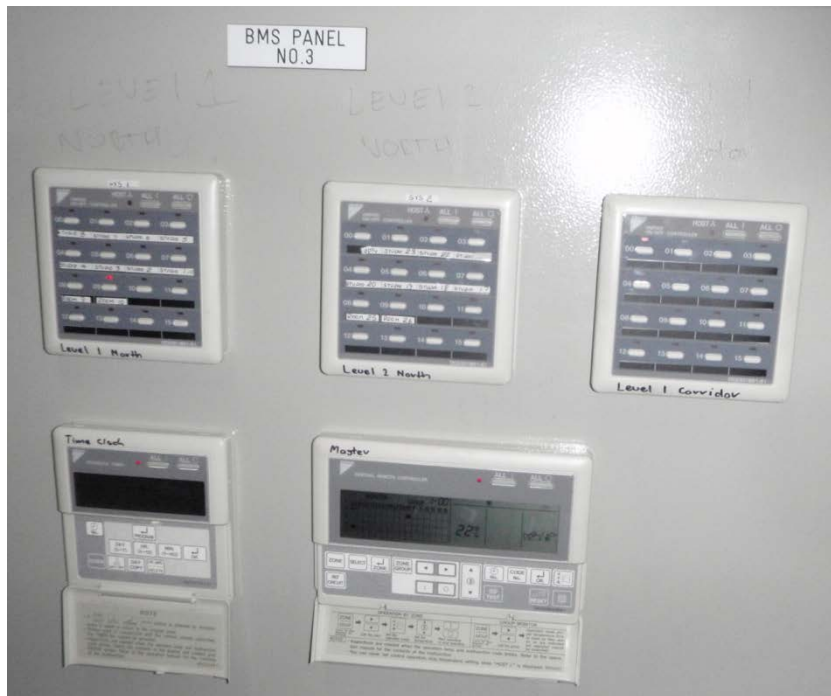
Figure 19: Studio and teaching

JSPAC has previously received quotes from the BMS contractors to investigate and potentially resolve these issues but these have not been followed through due to the high costs involved. The studio and teaching room air conditioning units are controlled by a separate BMS which defines operating schedules and temperature set points for these rooms.

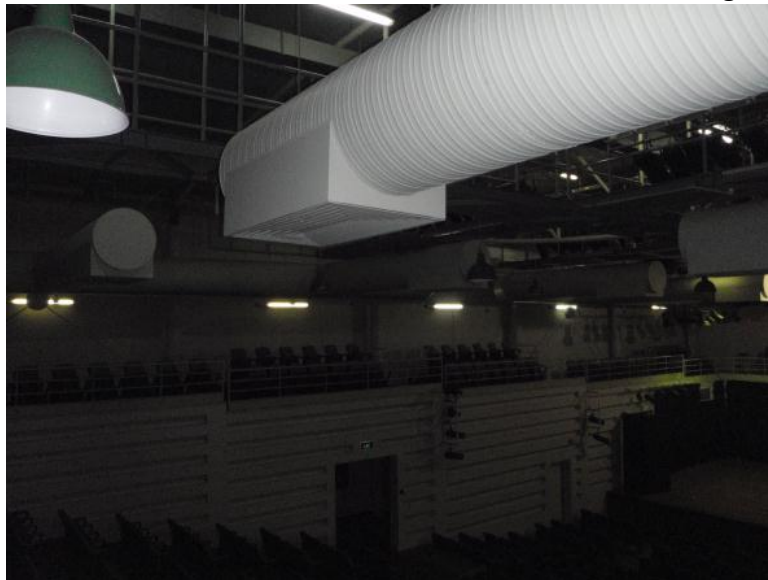
As noted in Section 6.5.2, site technical and maintenance staff reported issues experienced by concert hall audience members with temperature stratification. This was thought to be more of an issue towards the back of the hall where the HVAC diffusers are closer to the seating.

Figure 20: Concert Hall HVAC diffusers

The desired outcome is to change the discharge pattern to reduce the 'throw' and/or 'drop' of the conditioned air in this area. This could be achieved by a number of approaches including adjusting terminal velocity at the diffuser and changing the current louver faced diffusers to a diffuser that more effectively mixes the incoming cold air with concert hall air prior to reaching the audience. This could be done at an estimated cost of \$500.
