PENRITH CITY COUNCIL

**CRANEBROOK OVERLAND FLOW
FLOOD STUDY**

AUGUST 2023

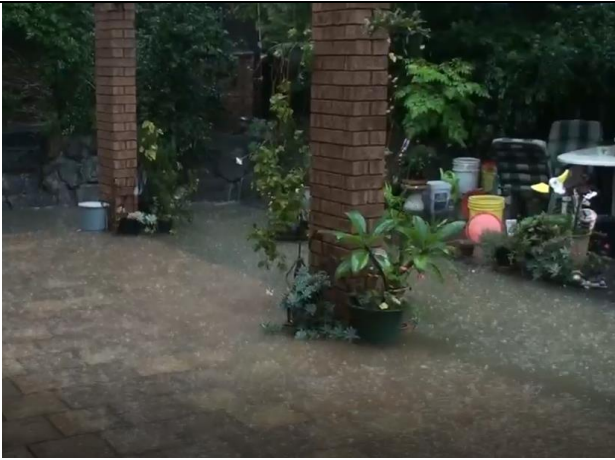
Plate C1.1 – (Photo taken at 19:00 hours) Floodwater ponding in rear of property that is located on Soling Crescent, Cranebrook.

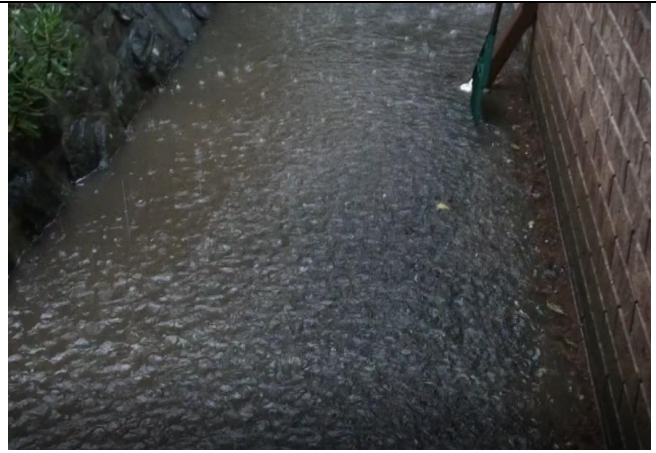
Plate C1.2 – (Photo taken at 19:00 hours) Floodwater ponding at side of property that is located on Soling Crescent, Cranebrook.

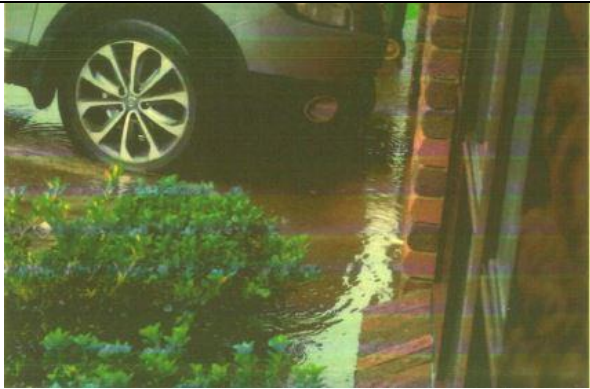
Plate C2.1 – Floodwater ponding at front of property that is located on Barry Coe Place, Cranebrook.

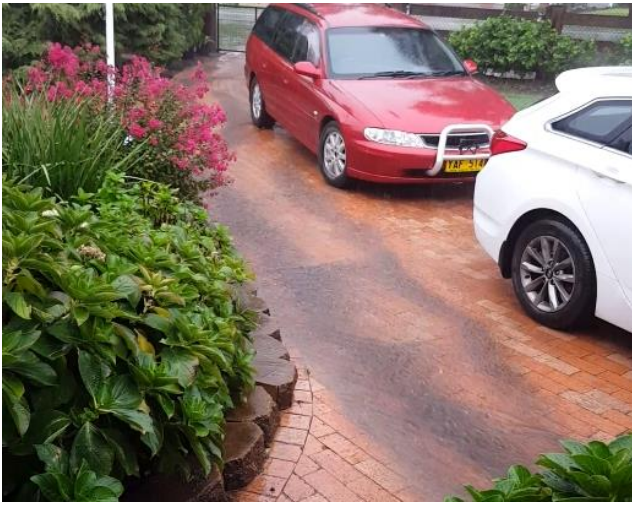
Plate C3.1 – (Photo taken at 17:30 hours) Overland flow along driveway of property that is located on Linden Crescent, Cranebrook.

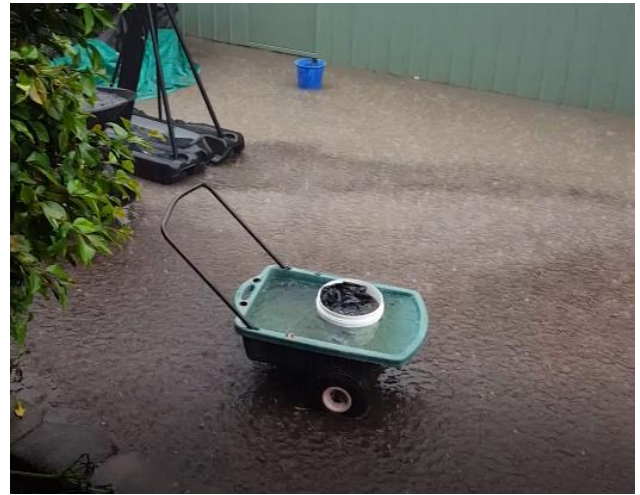
Plate C3.2 – (Photo taken at 17:30 hours) Floodwater ponding at rear of property that is located on Linden Crescent, Cranebrook.

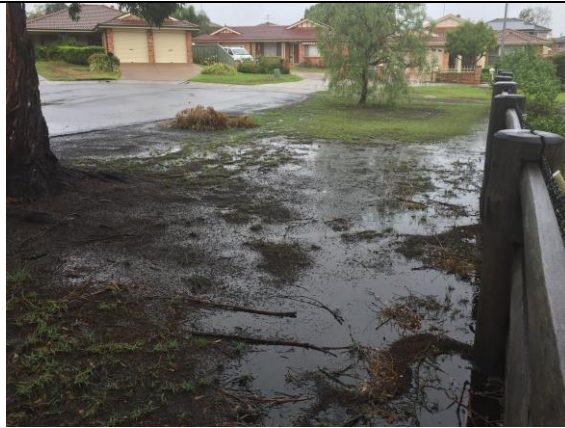
Plate C4.1 – Floodwater ponding between road and front of properties that are located on the western side of Linden Crescent, Cranebrook.

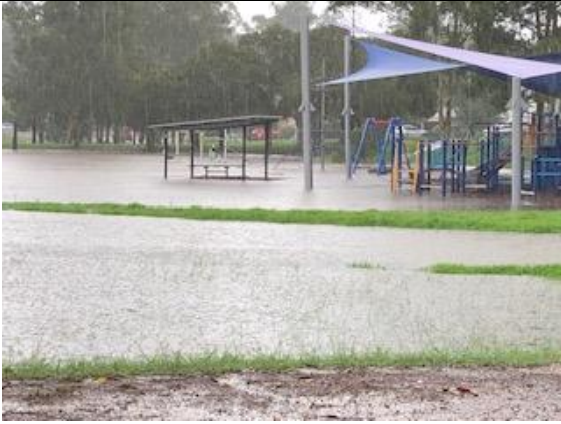
Plate C5.1 – (Photo taken at 12:00 hours) Floodwater ponding in the Borrowdale Way Basin No. 1.

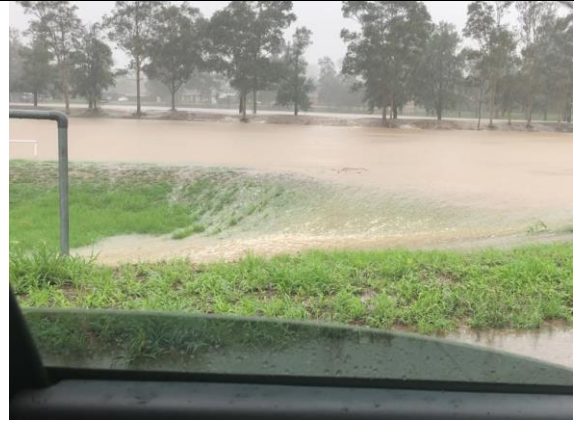
Plate C5.2 – (Photo taken at 15:00 hours) Floodwater surcharging the spillway of the Borrowdale Road Basin No. 2.

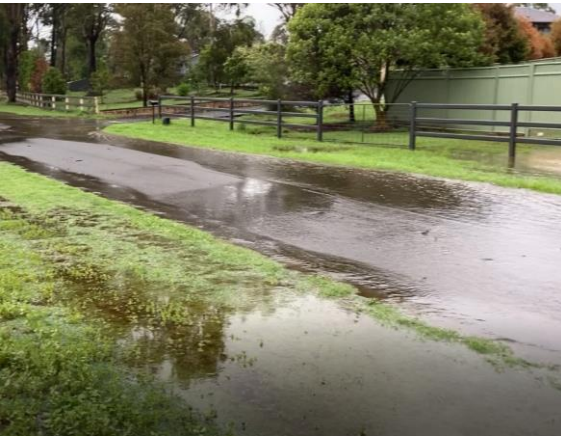
Plate C5.3 – Flooding on Woodside Glen, Cranebrook.

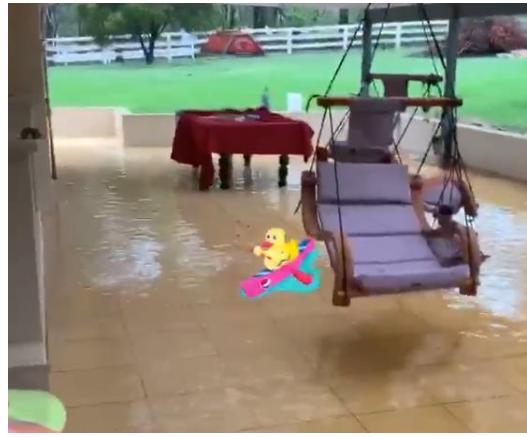
Plate C5.4 – (Photo taken at 11:40 hours) Flooding in rear of property that is located on Woodside Glen, Cranebrook.

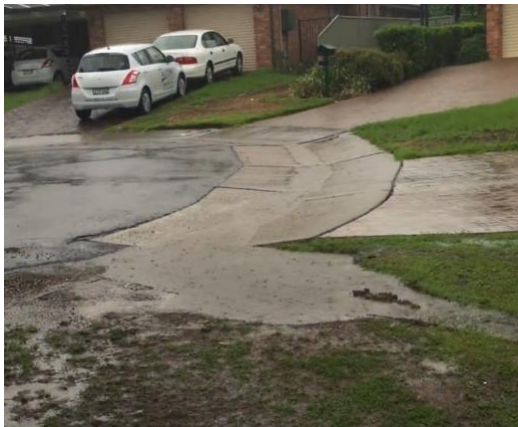
Plate C5.5 – (Photo taken at 10:00 hours) Concentrated flow discharging from gutter in Linden Crescent, Cranebrook.

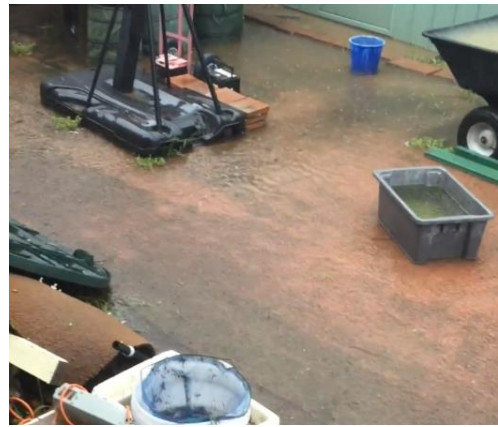
Plate C5.6 – (Photo taken at 13:30 hours) Floodwater ponding at rear of property that is located on Linden Crescent, Cranebrook.

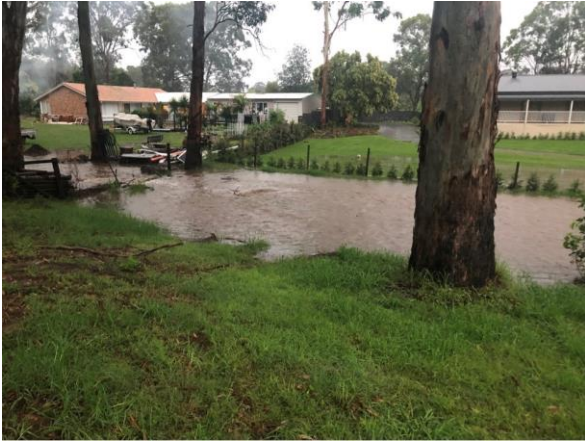
Plate C5.7 – Flooding on property that is located on Kenilworth Crescent, Cranebrook.

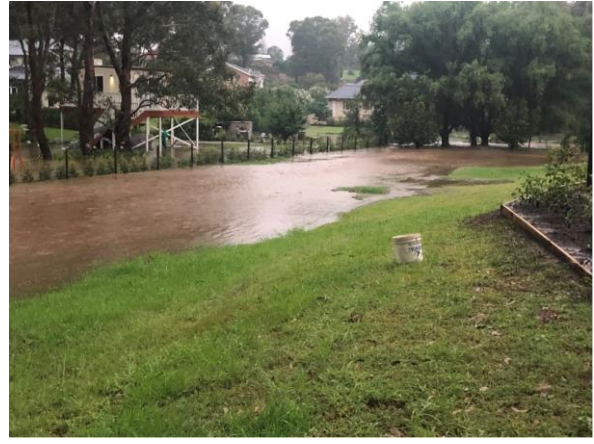
Plate C5.8 – Flooding on property that is located on Kenilworth Crescent, Cranebrook.

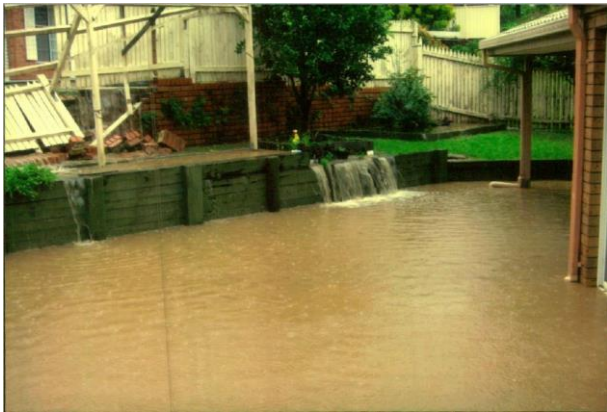
Plate C6.3 – Flooding at rear of property that is located on Waterfall Crescent, Cranebrook.
